SUGAR-MILL COUPLING DEVELOPMENTS SINCE 1987

C.T. TOSIO

Eurogear (Pty) Ltd, Johannesburg, South Africa

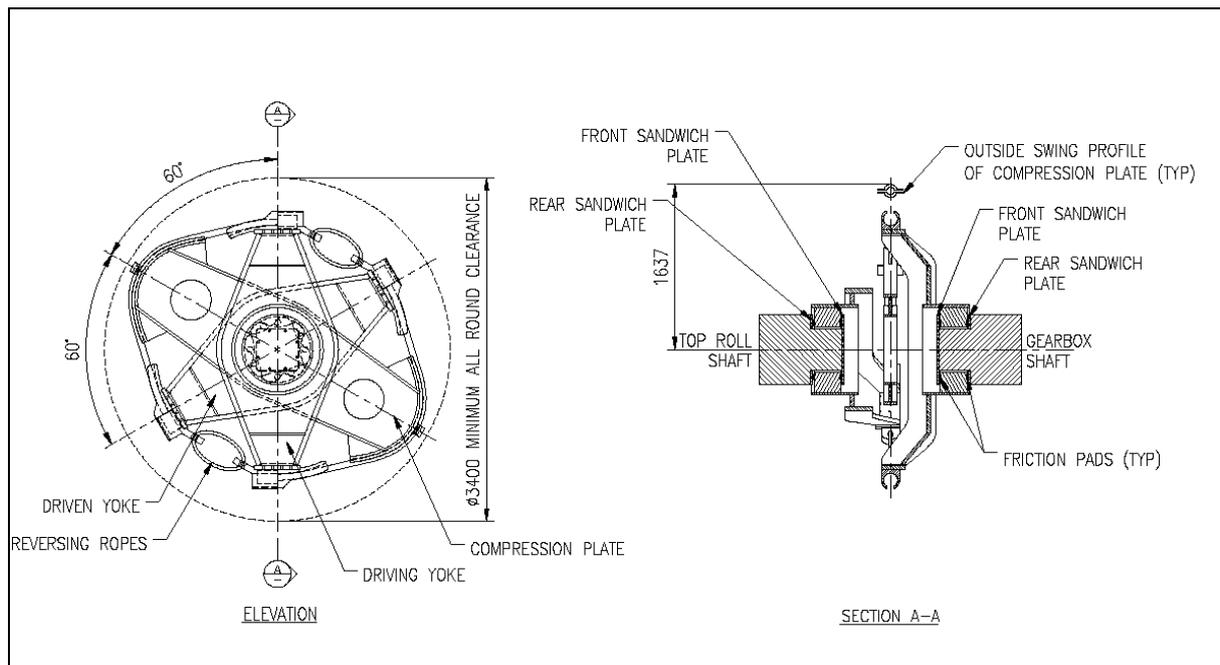
The SWR (Steel-Wire-Rope) coupling is shown in Figure 1.

Fig. 1—The SWR coupling.

The ropes connect the driving and driven yokes in a plane normal to the shaft axes via a floating strut that bends the ropes into two parallel pairs of flexible members roughly at right angles to one another.

Considered in static mode, the pair of near-horizontal ropes can absorb vertical misalignment, while the near-vertical pair of ropes can absorb horizontal misalignment. In addition, any axial movement can be absorbed by all the ropes flexing sideways.

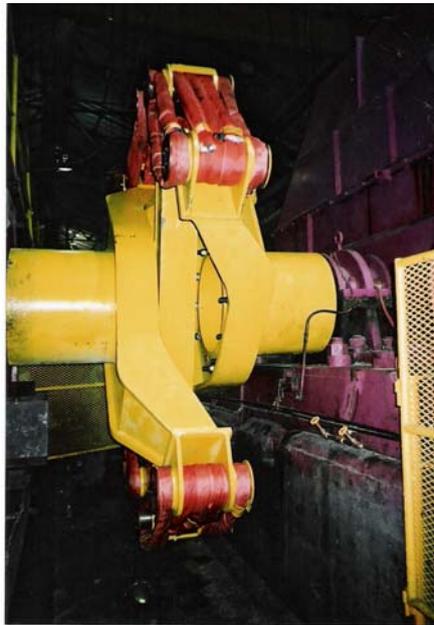
Two other flexible members have subsequently replaced the steel wire ropes, namely polyester slings (Figure 2) and link plates fitted with maintenance-free spherical plain bearings (Figure 3).

Fig. 2—Rope coupling with polyester slings.

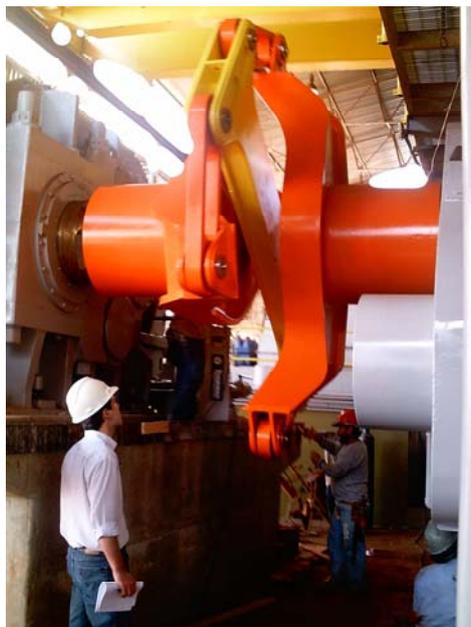
Fig. 3—Rope coupling with link plates fitted with spherical plain bearings.

Spherical plain bearings have not achieved the life predicted by the suppliers, but there are numerous reasons for this, the main causes being abuse during operations and poor storage practices during the off-crop.

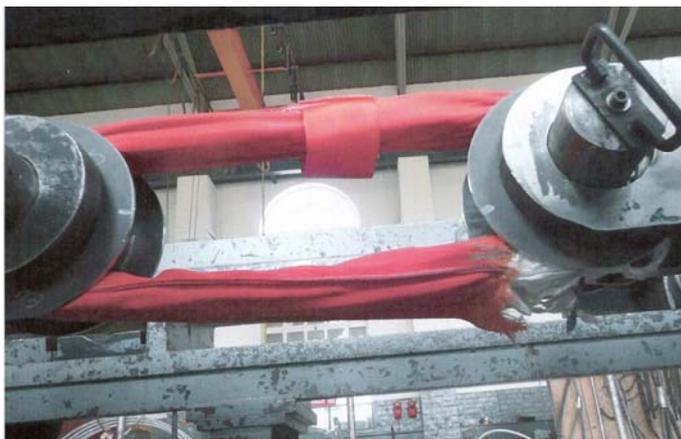
The polyester slings (Figure 4) are proving very reliable, although attention has to be paid to the following to ensure they work as designed:

- It is essential that the slings are all the same length so they share the load equally.
- The slings have to be manufactured very uniformly in cross-section so that all the strands share the load equally.
- Frequent destructive tests should be carried out on slings to be sure design service factors are maintained, and that fabricators are not cutting corners.

Fig. 4—Polyester sling undergoing destructive test.

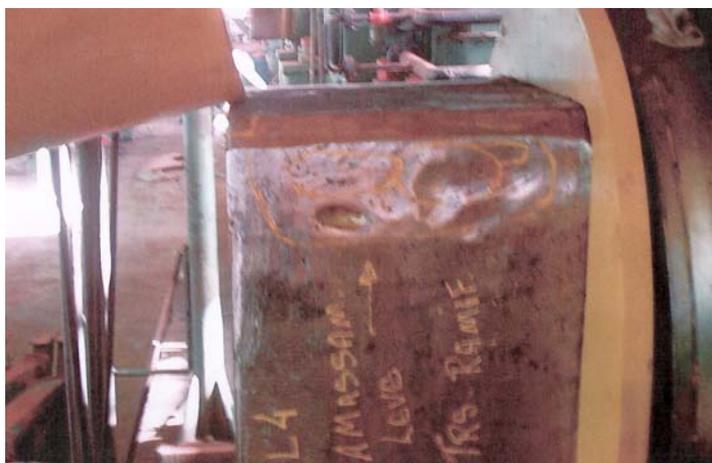
The biggest challenge in the first 10 years of making couplings was to design a good system of fitting yoke-hubs onto shaft-squares that were never, in fact, square. From very early days, all engineers have been advised (in our data sheet that they complete) to restore shafts to original dimensions, and make sure they are square. A typical, non-square, shaft square is shown in Figure 5.

Fig. 5—An un-repaired shaft square.

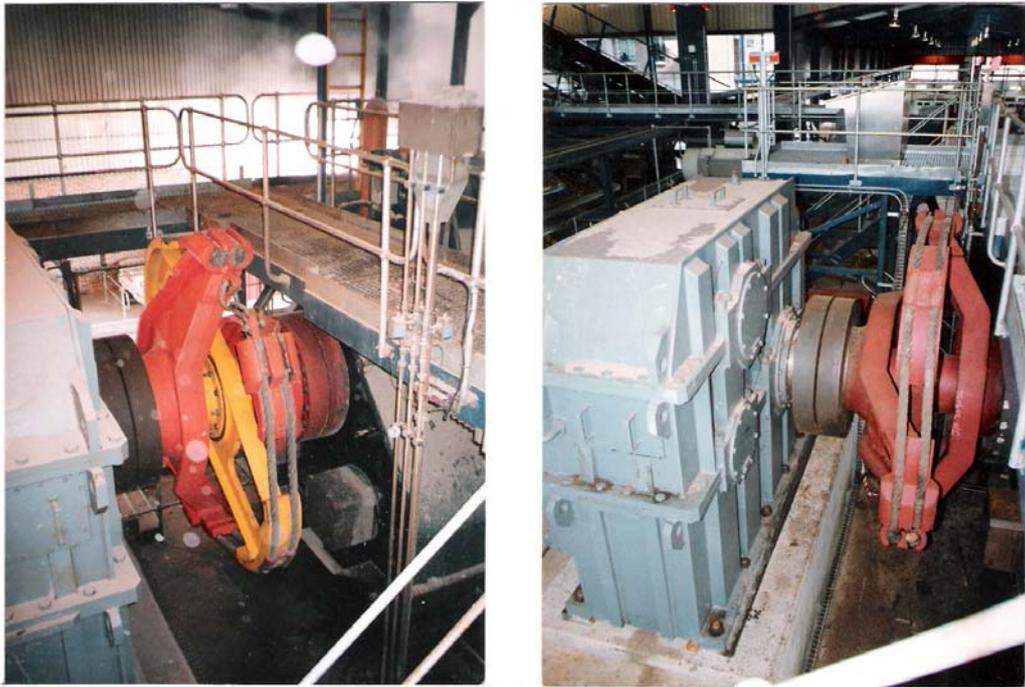
Hubs were then fitted onto shafts using heavy-duty shrink-discs (Figure 6). This method works very well if squares are accurately machined and square, so is good for new installations such as at the Komati factory in South Africa in 1994. This method also requires excessive fitting time and was not deemed suitable for retro-fit installations. Lighter shrink-discs (quicker to fit) were tried but also required close shaft-tolerances. Old shaft-squares are never properly repaired or restored to original dimensions, so this system was also discontinued.

Fig. 6—Shrink-discs used to fit couplings to shafts.

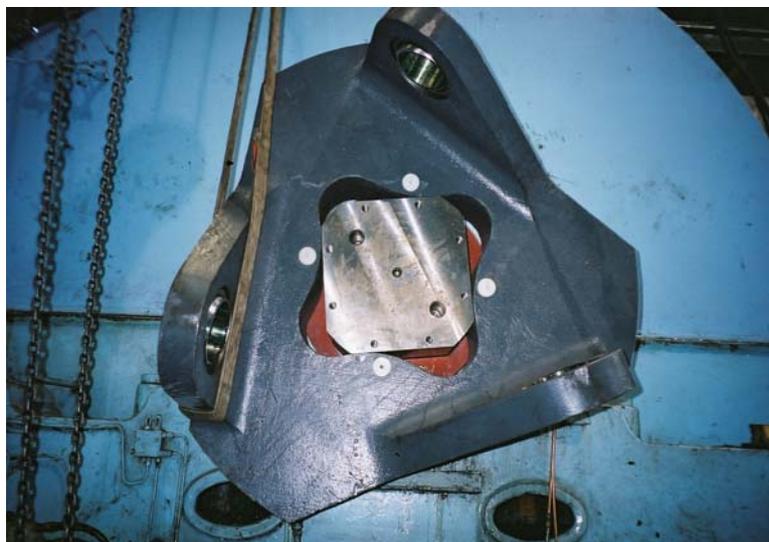
The final solution to fitting problems was introduced in 1996 when a new profile bore design was introduced (Figure 7), and it has been so successful there is no intention to change it.

Fig. 7—Hub fitting on shaft.

This strange-looking slide-on design has a cast or profile-cut bore with very large corner radii, which minimises stresses. In taking load, the bore makes contact close to, but not quite on, all four corners of the square. Note each bore-profile has to be specially designed to fit in the optimum position. Initially the arc-to-flat contact is only line contact, but this line crushes immediately load is applied until the flattened area is so large that the stress falls below the yield point of the hub material, which is always softer than the shaft.

This design caters to small shaft-square dimensional inaccuracies, and always ensures four-corner load-sharing. It also optimises the hub thickness and therefore minimises the cost of manufacture. It can distort slightly should this be necessary, thereby ensuring that all corners are equally loaded. The hubs are retained on the outside ends of the squares by sets of ‘Sandwich’ plates (Figure 8).

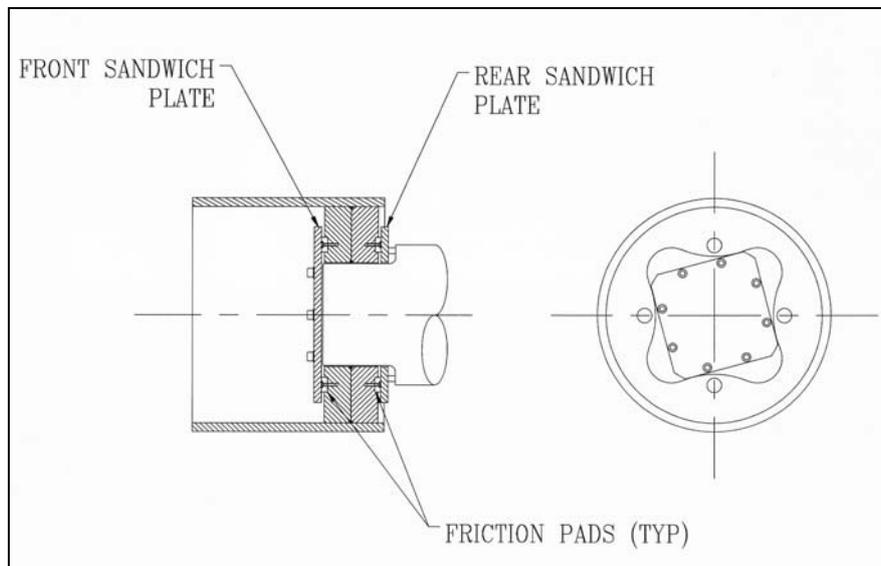
Fig. 8—Hub fitting on shaft.

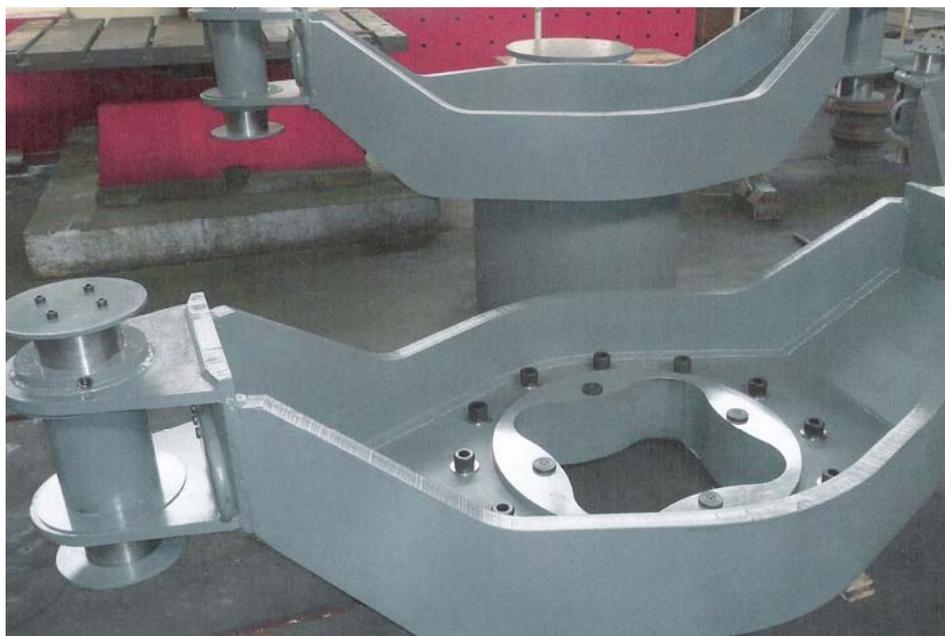
The shear-pins, shown in Figure 9, are always fitted to a pair of flanges integral with the gear-side hub or tube-to-yoke connection. The flanges are fitted with hardened bushes to support the shear pins without themselves being damaged.

In the event of the shear pins failing, the coupling stops turning, providing a very visible indication of a problem. The cause of the failure can then be investigated and the shear pins can be replaced. Shear pin replacement takes only a few minutes.

Fig. 9—Yoke-to-Hub connection showing shear pins.

For the past five years, all designs have had a torque limitation option in the form of shear pins to protect the mill and (more importantly) gearbox from damage should a pinion break or a large object enter the mill and cause a stall. For design purposes, a break torque of 150% of estimated normal driving torque has been used.
